1. AGENCY USE ONLY (Leave blank)	2. REPORT DATE 1996	3. REPORT TYPE AND DATES COVERED Final Report		
4. TITLE AND SUBTITLE The Old Hospital Complex (5EP1778) Fort Carson, Colorado		5. FUNDING NUMBERS

13. ABSTRACT (Maximum 200 words) <p>The Old Hospital Complex (5EP1778) at Fort Carson, Colorado, consists of 59 buildings. The Complex was built during World War II and is significant due to its association with the history of the United States. The complex is semi-permanent construction, constructed from the Department of the Army's Series 800 plans. This report documents the complex in accordance with Section 1(g) of the Memorandum of Agreement enacted among the Department of the Army, Headquarters Fort Carson, the Colorado State Historic Preservation Office, and the Advisory Council on Historic Preservation.</p> <p style="text-align: center;">DTIC QUALITY INSPECTED 2</p>

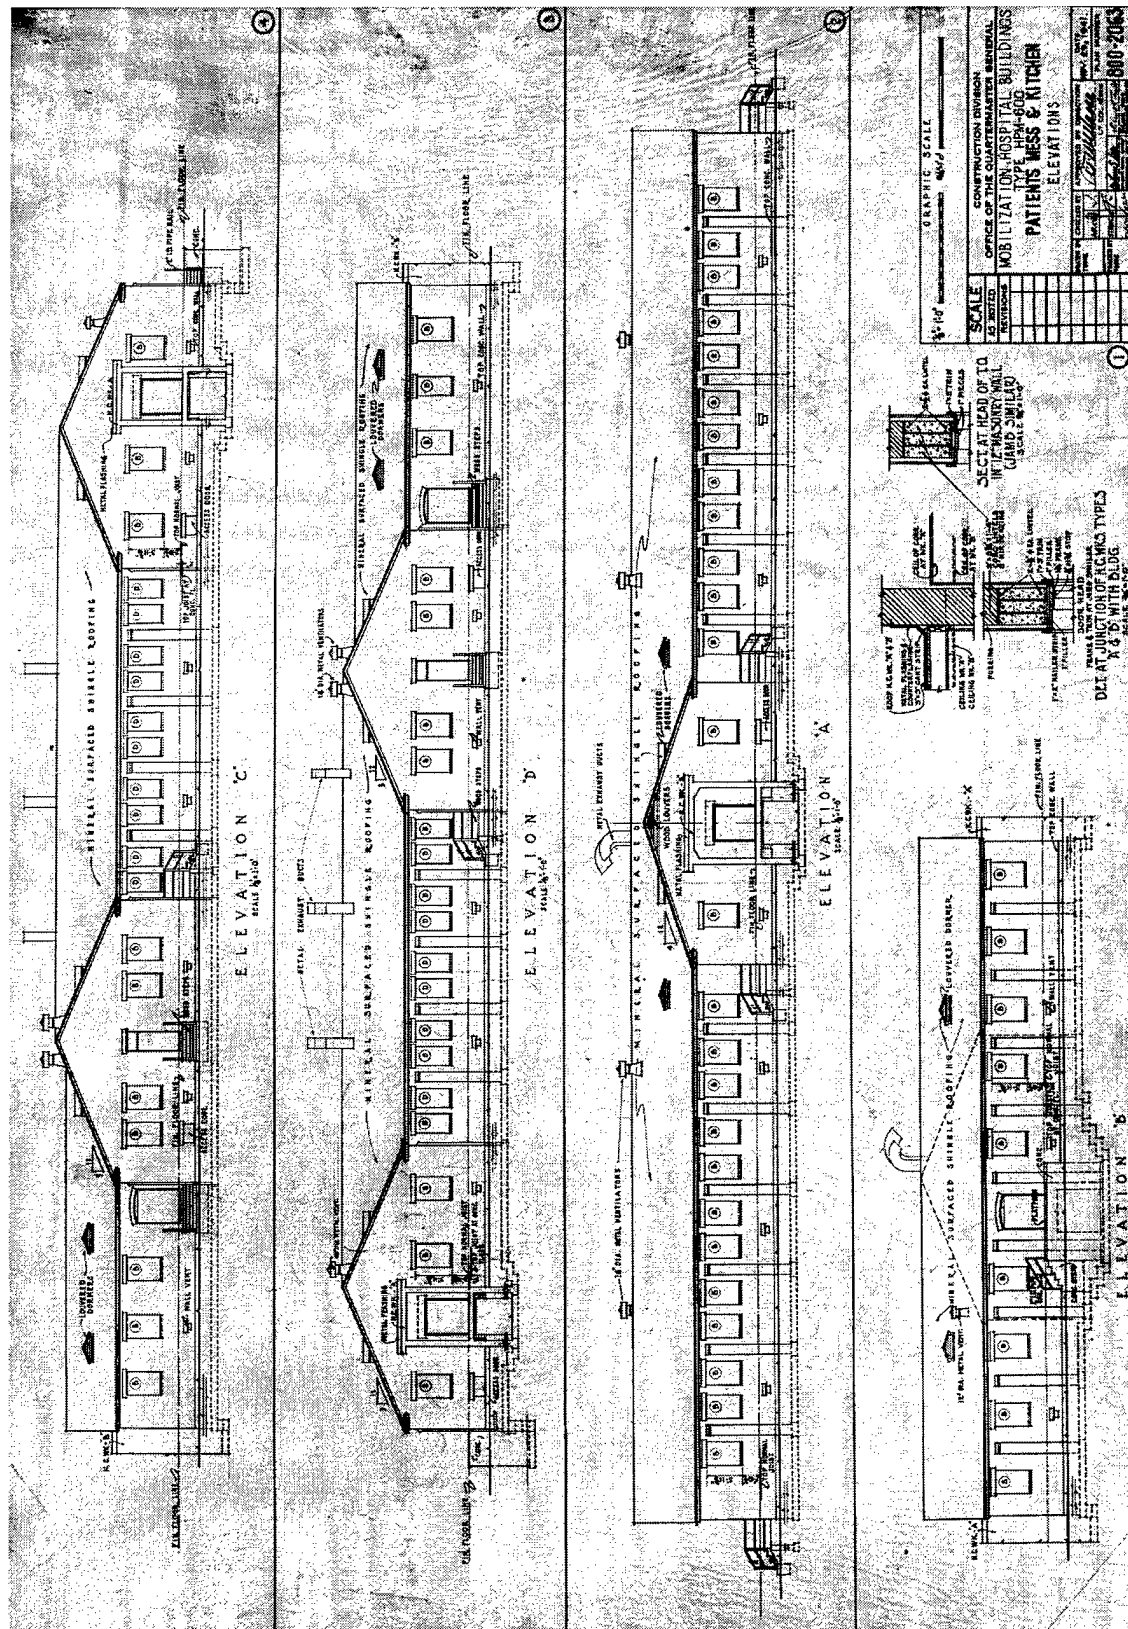
Figure V.188 SEP1778. Elevations for Building S6250, Patients Mess and Kitchen, 800 Series, Type HPM-600, Plan 800-2063.

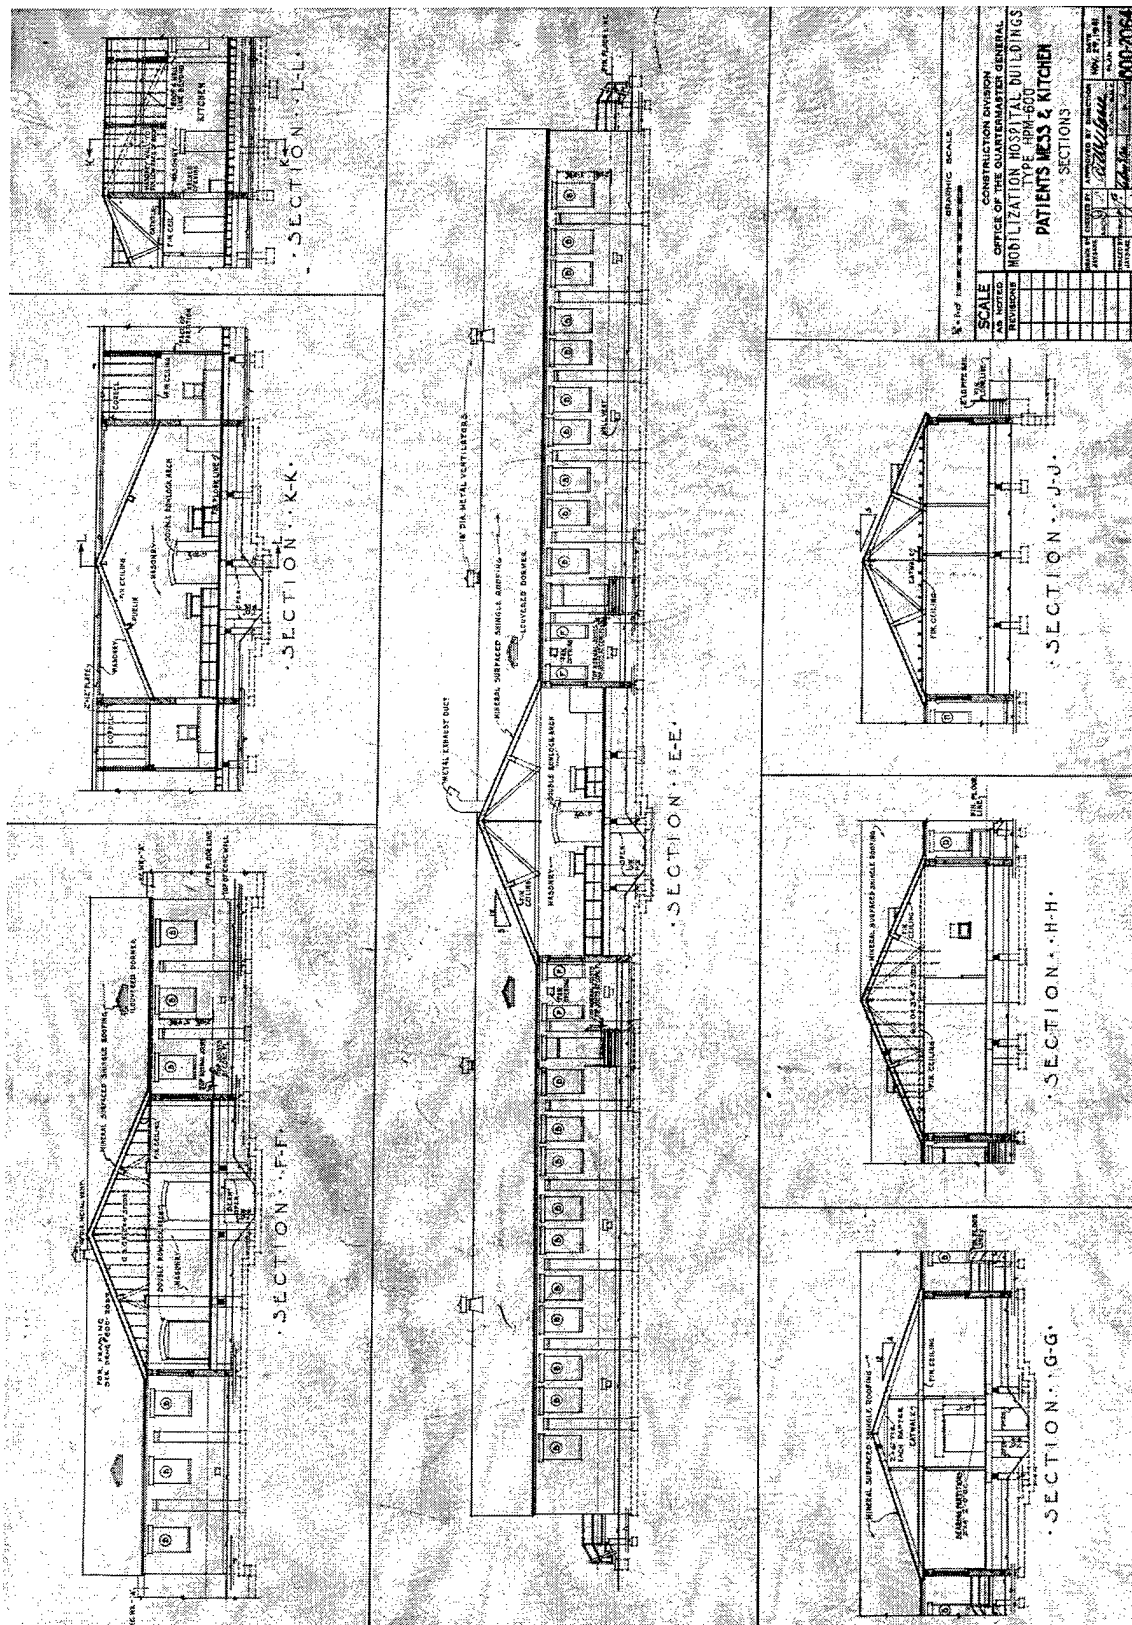
Figure V.189 SEPI778. Section plans for Building S6250, Patients Mess and Kitchen, 800 Series, Type HPM-600, Plan 800-2064.

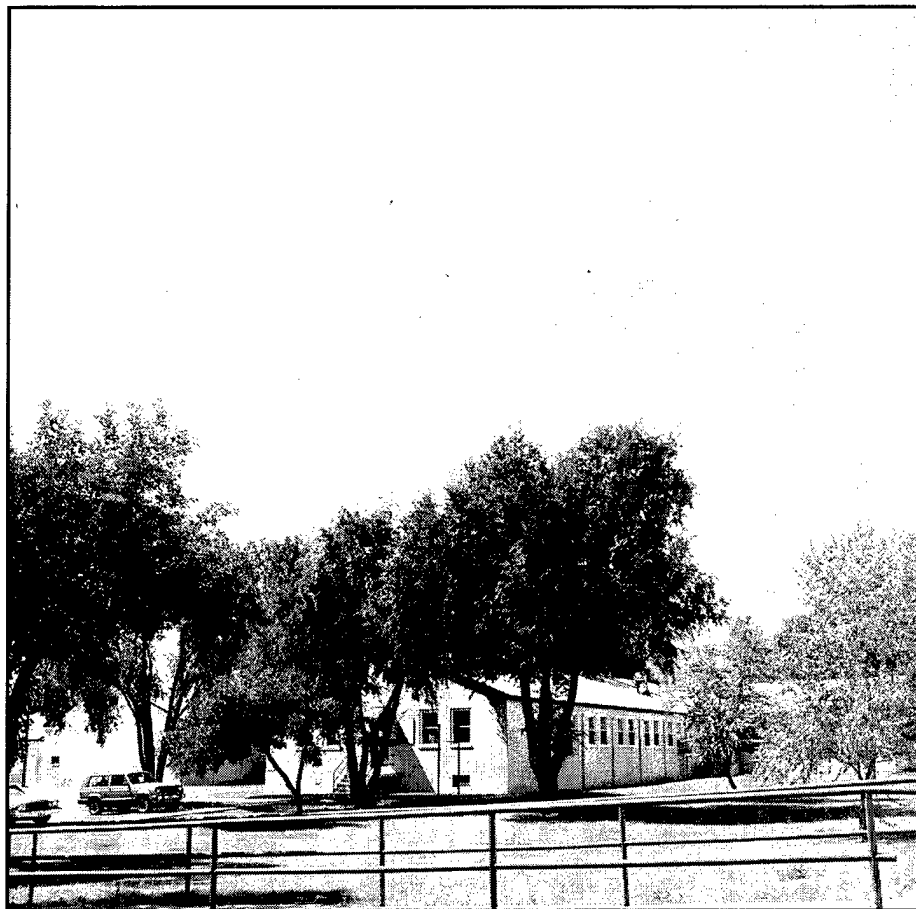
Figure V.190 5EP1778. Building S6250, Patients Mess and Kitchens, 800 Series, Type HPM-600. Three-quarter view of north and east faces. Roll 1J, Exposure 1.

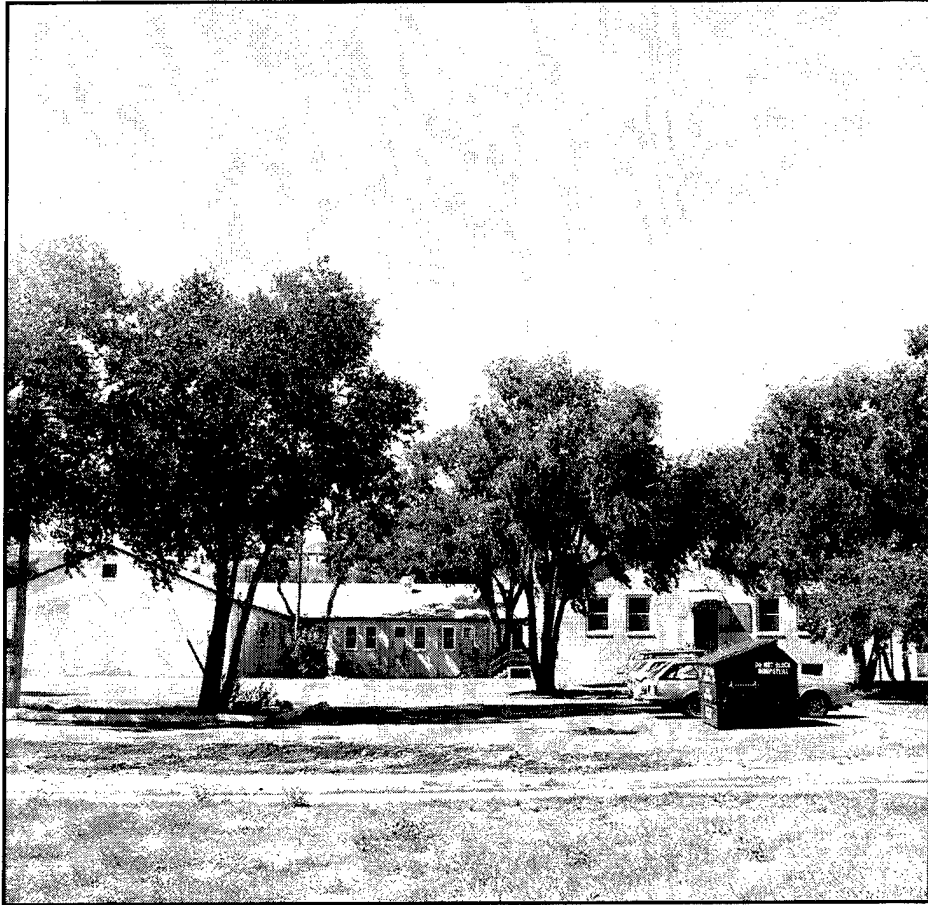
Figure V.191 5EP1778. Building S6250, Patients Mess and Kitchen, 800 Series, Type HPM-600. East face. Roll 1J, Exposure 5.

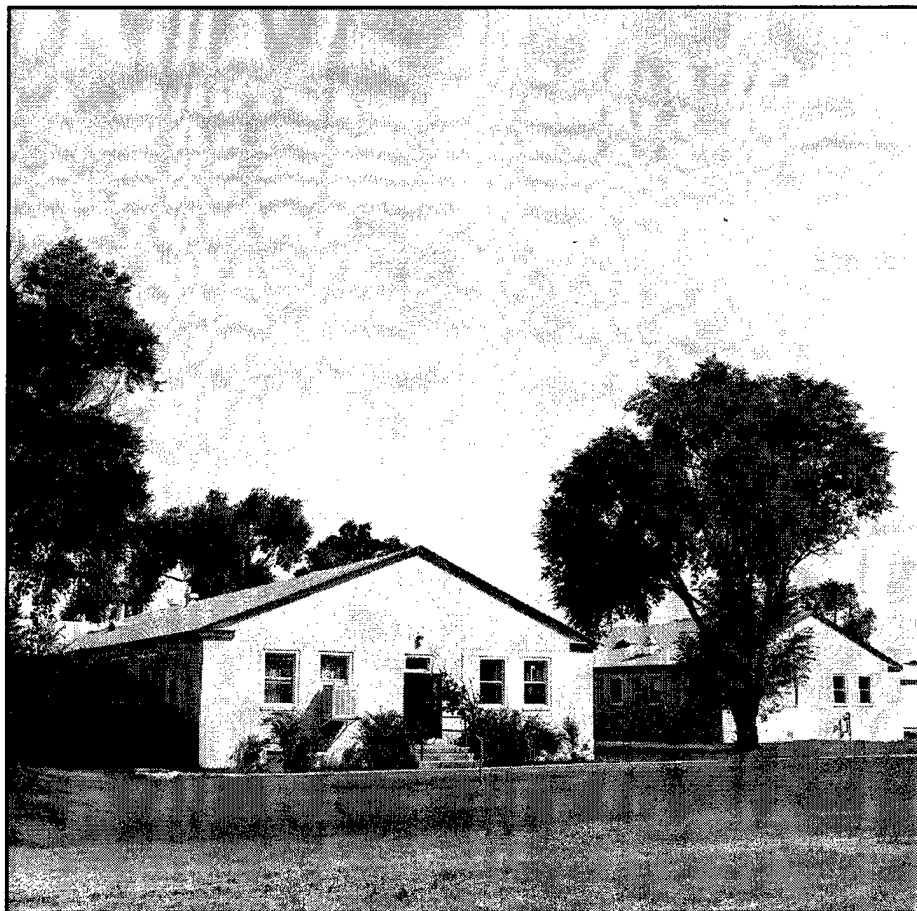
Figure V.192 5EP1778. Building S6250, Patients Mess and Kitchen, 800 Series, Type HPM-600. Three-quarter view of north and west faces (excludes northernmost west face). Roll 2J, Exposure 11.

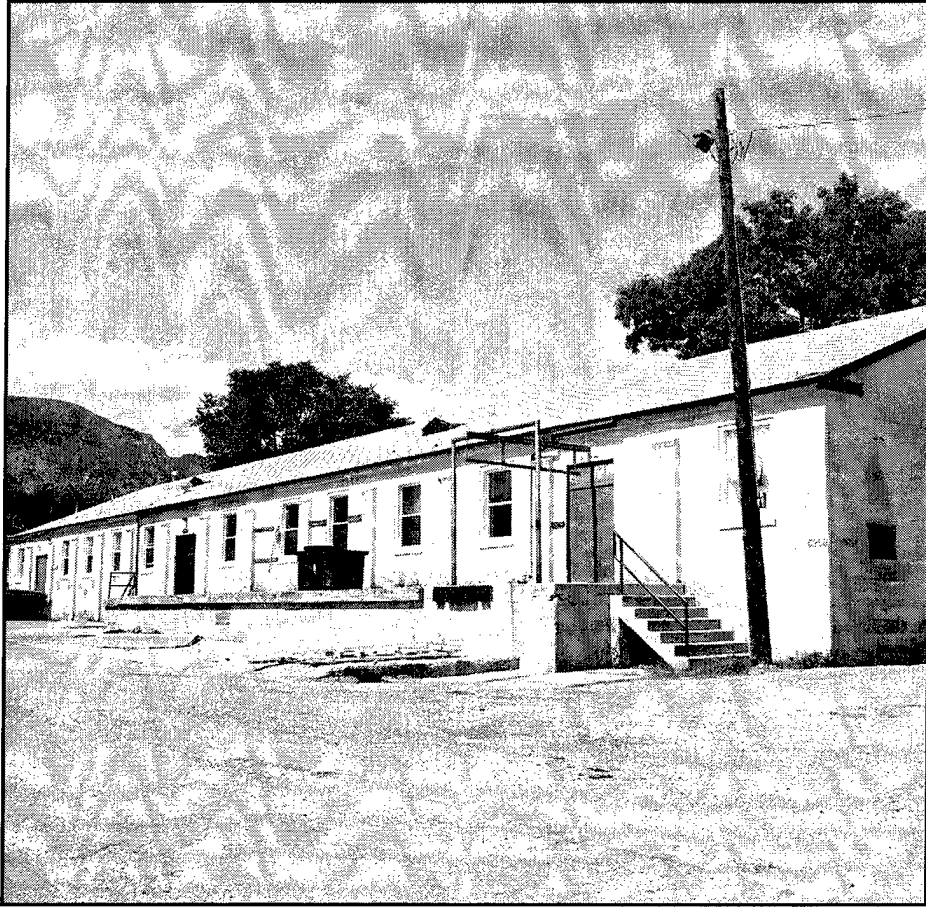
Figure V.193 5EP1778. Building S6250, Patients Mess and Kitchen, 800 Series, Type HPM-600. South face. Roll 2J, Exposure 3.

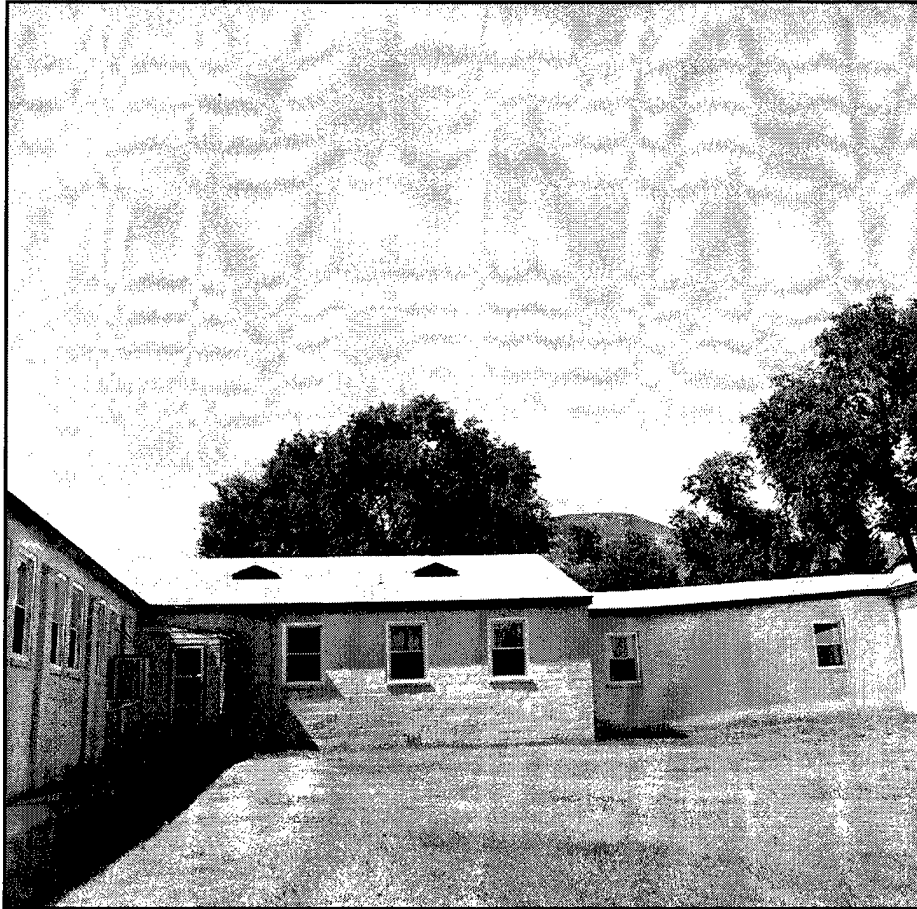
Figure V.194 5EP1778. Corridor connecting to northernmost wing of Building S6250, 800 Series, Type H.C.WK.-B. Roll 1J, Exposure 10.

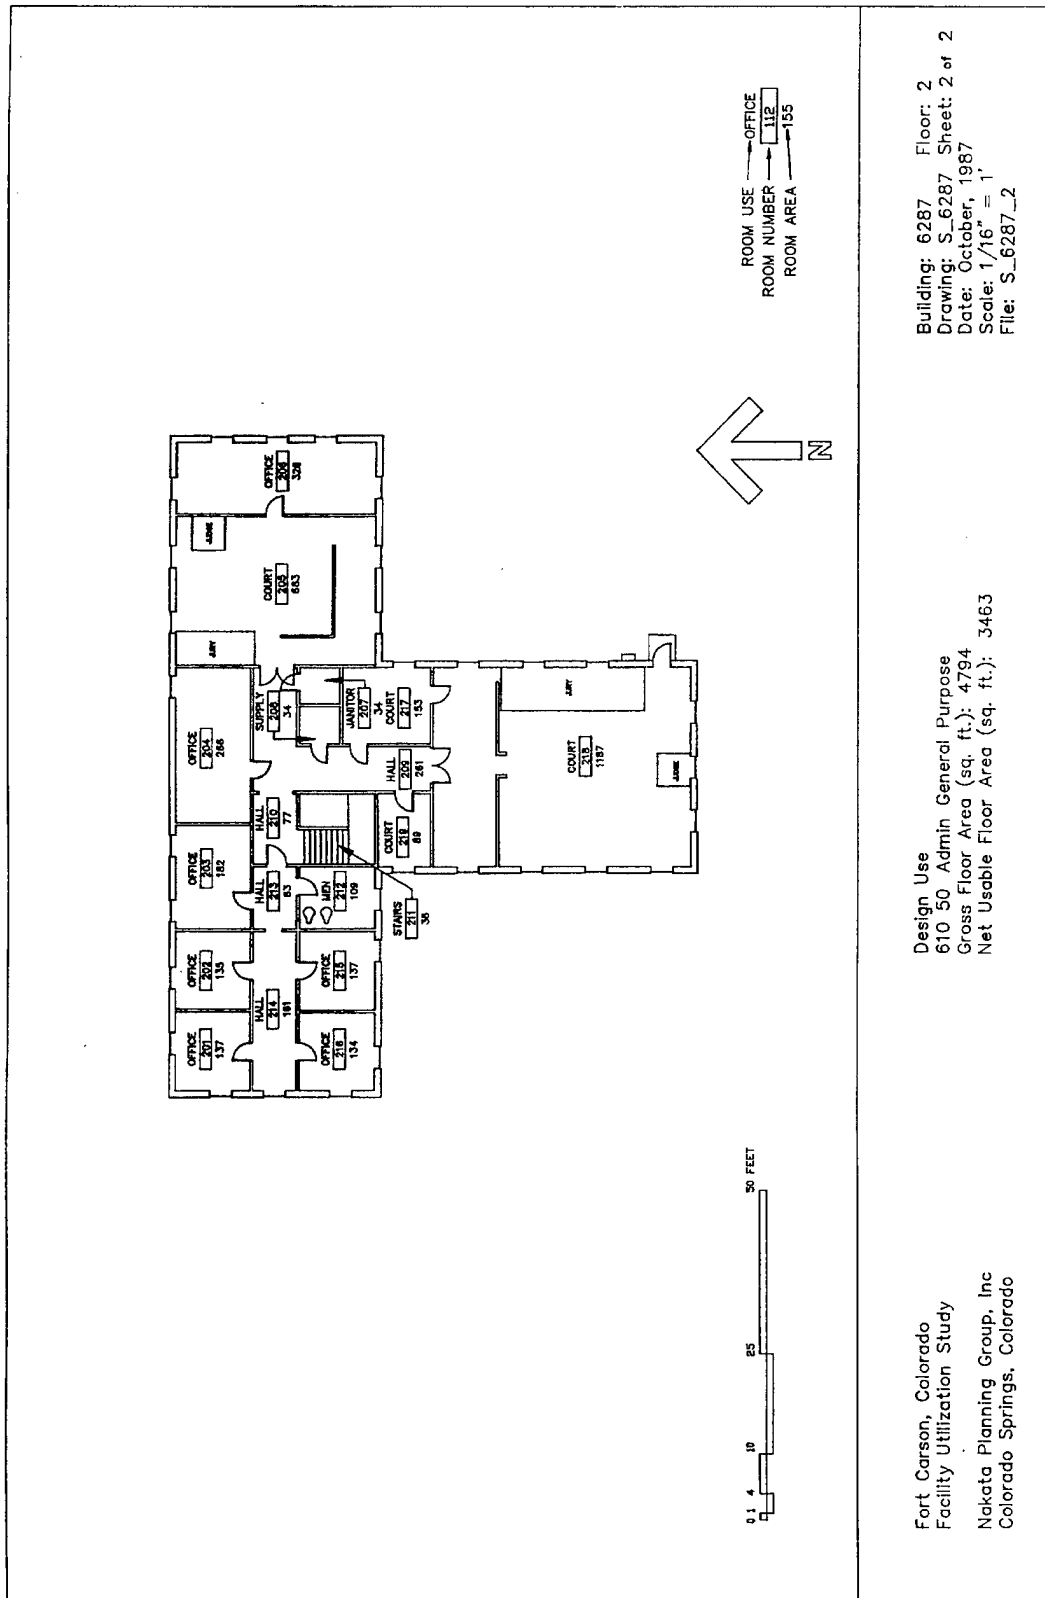
Figure V.197 5EP1778. Second-floor plan for Building S6287, Hospital Medical Detachment Recreation, BUD Series.

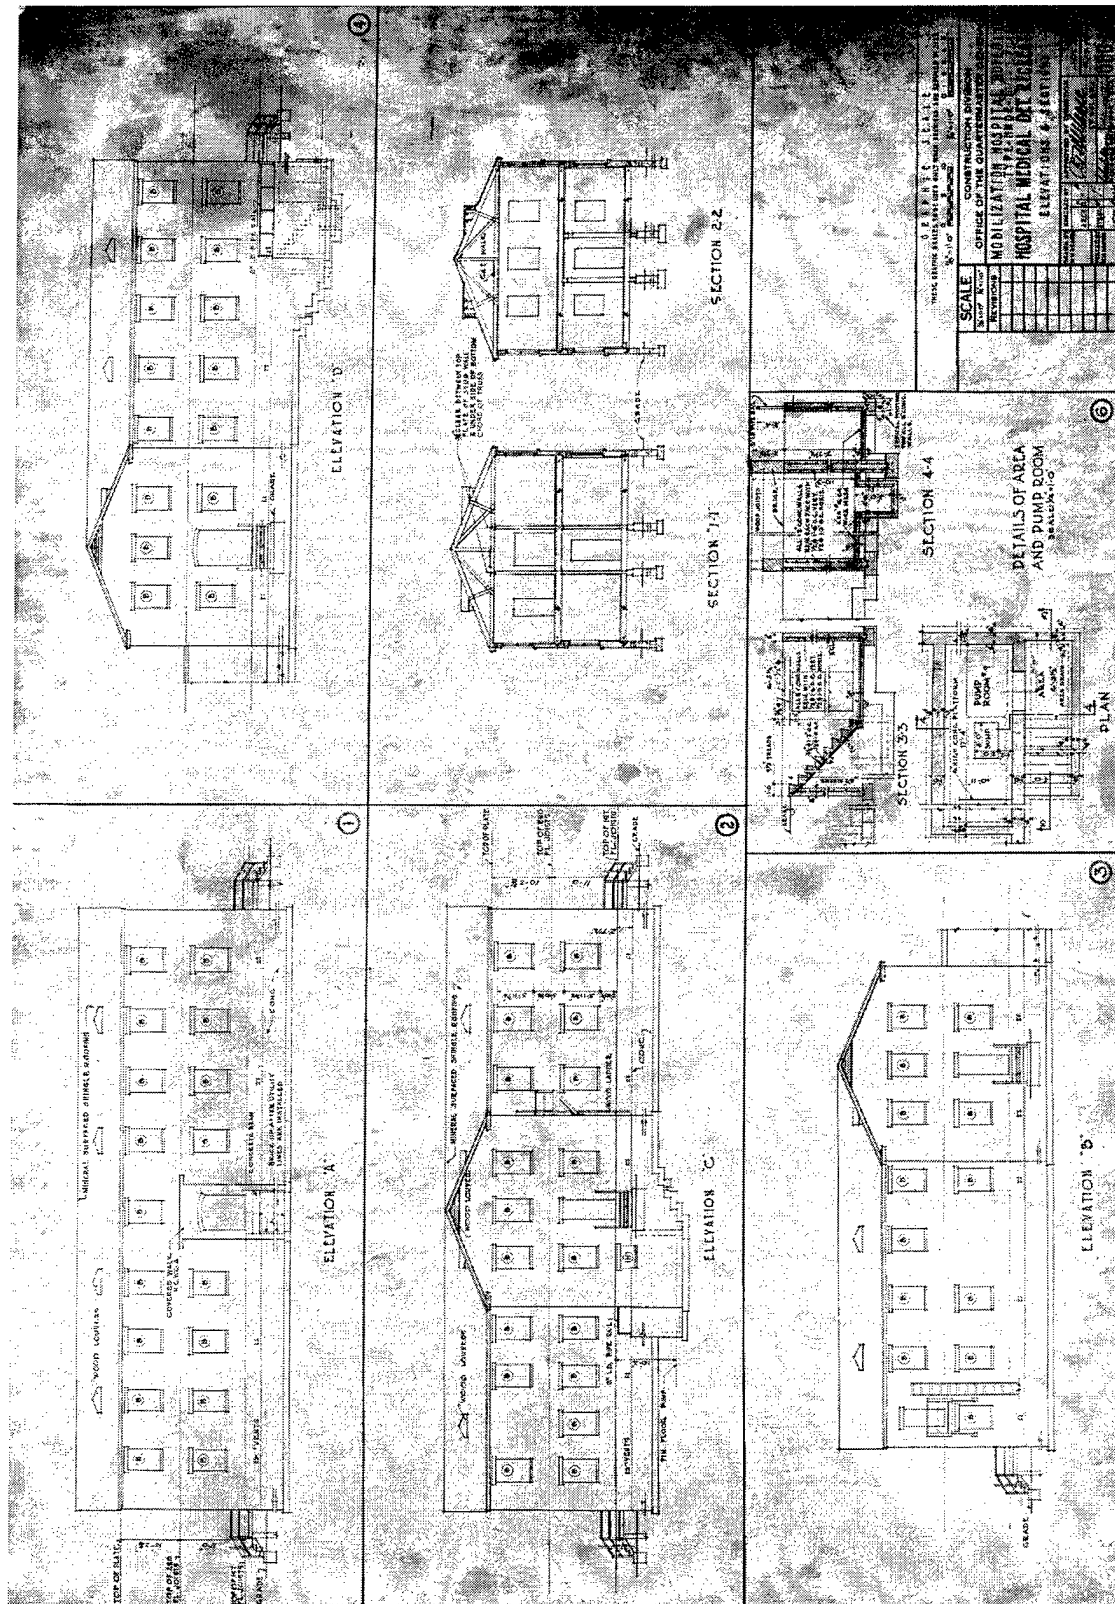
Figure V.198 5EP1778. Elevations and sections for Building S6287, Hospital Medical Detachment Recreation, 800 Series, Type HMDR-1, Plan 800-1812.

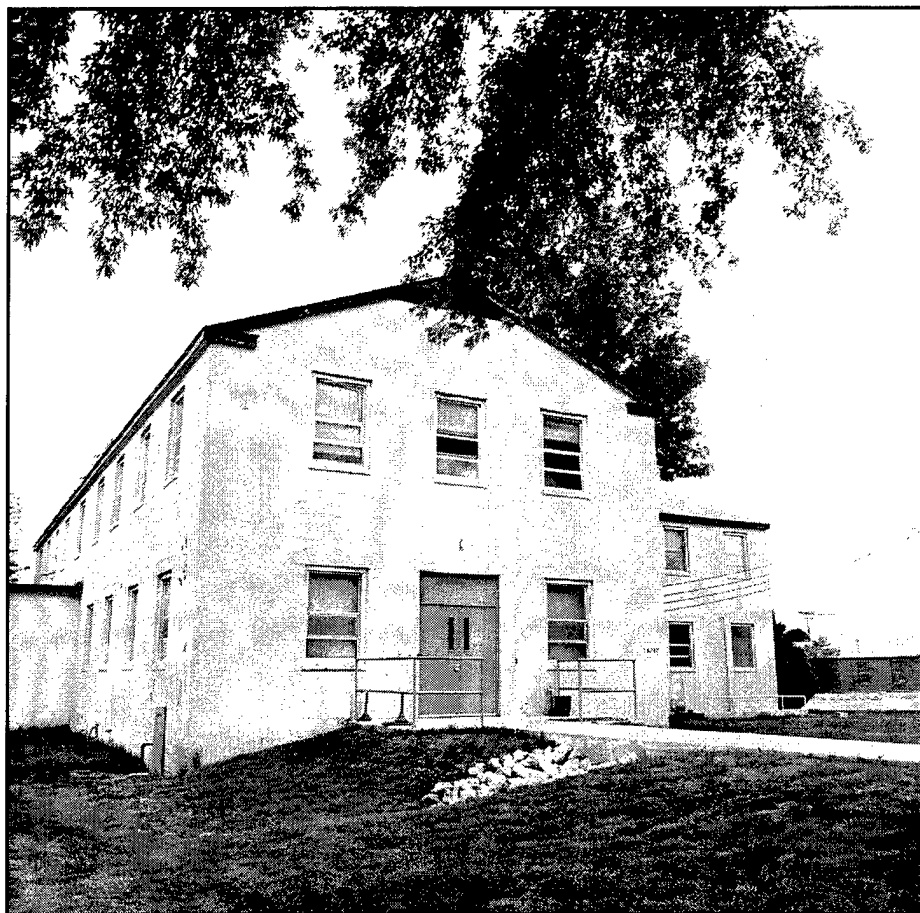
Figure V.199 5EP1778. Building S6287, Hospital Medical Detachment Recreation, 800 Series, Type HMDR-1. Three-quarter view of west side's west and north faces. Roll 8H, Exposure 10.

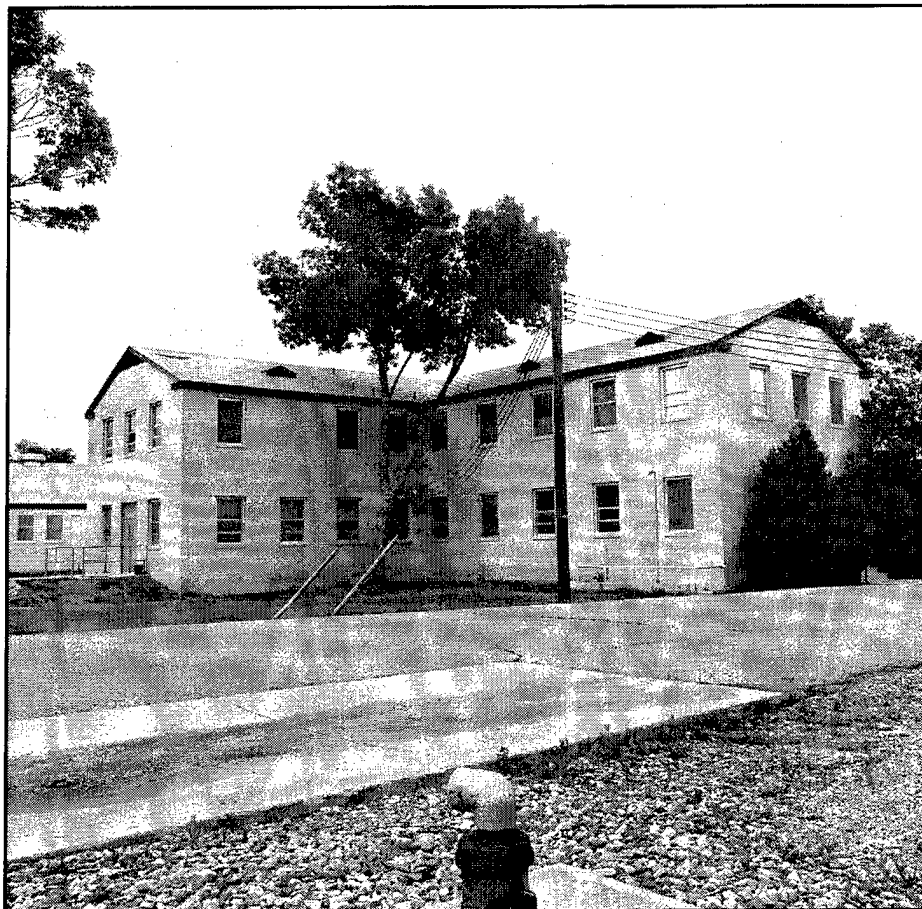
Figure V.200 5EP1778. Building S6287, Hospital Medical Detachment Recreation, 800 Series, Type HMDR-1. Three-quarter side showing south and west faces. Roll 8H, Exposure 2.

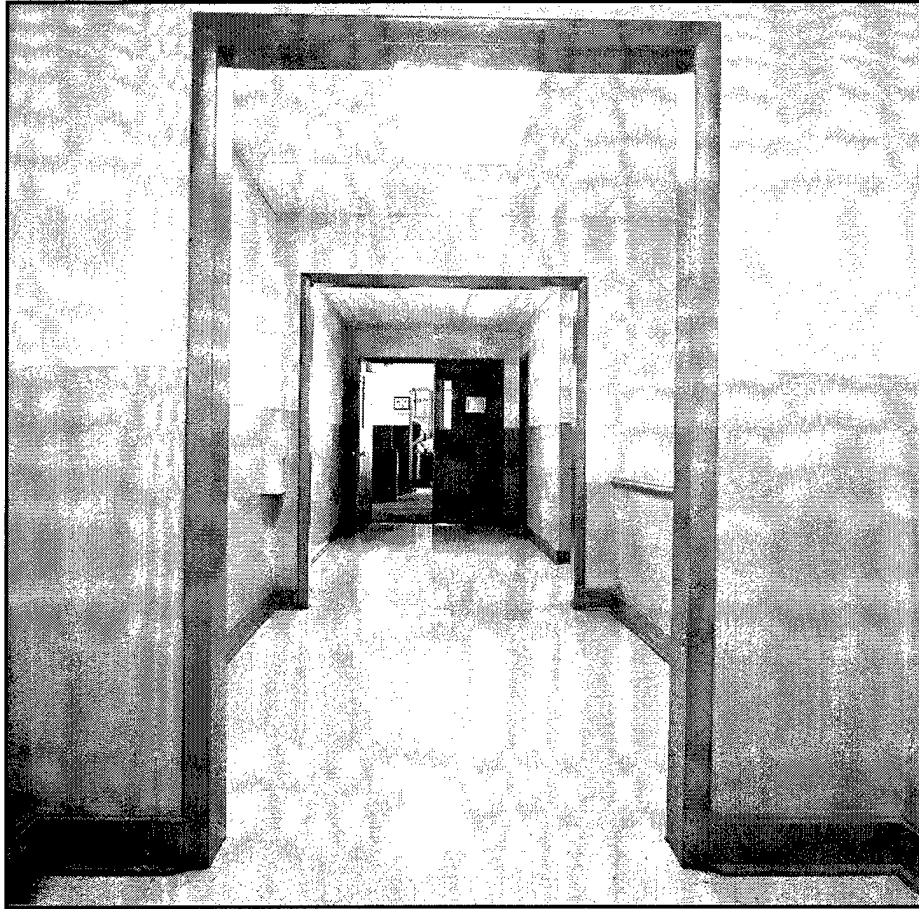
Figure V.201 SEP1778. Building S6287, Hospital Medical Detachment Recreation, 800 Series, Type HMDR-1. Interior shot of second floor hallway, facing east. Roll 2H, Exposure 10.

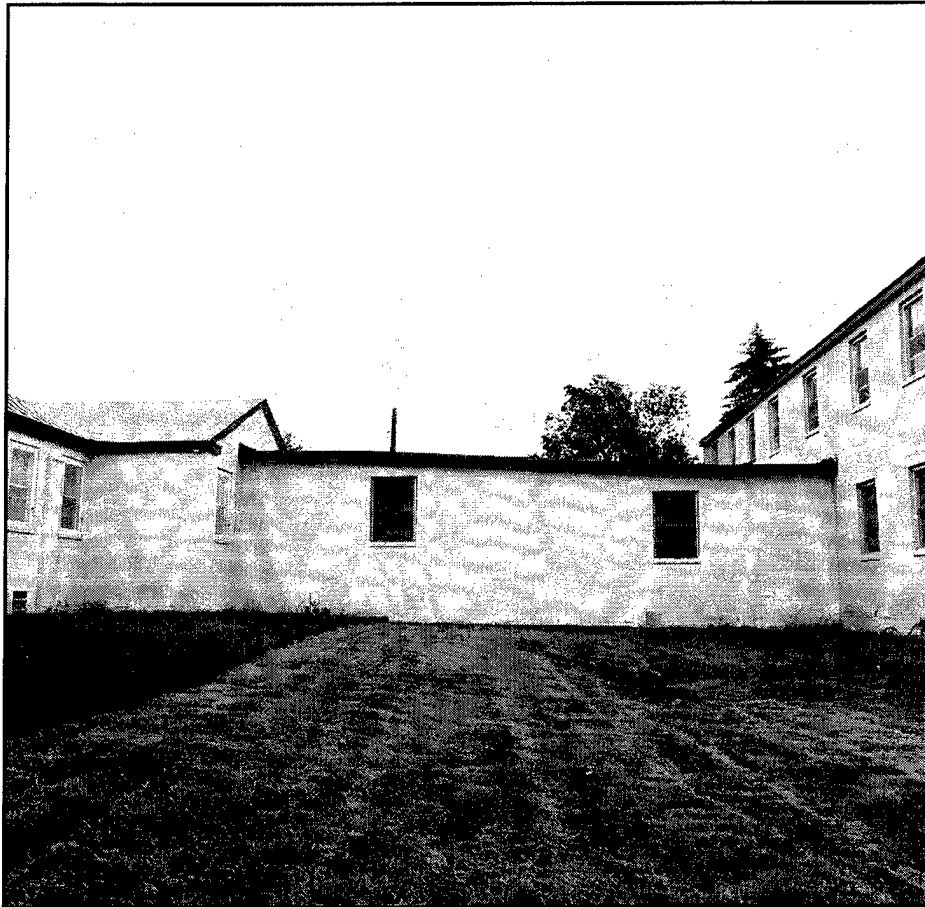
Figure V.202 5EP1778. West face of corridor connecting Buildings S6287 to S6286. 800 Series, Type H.C.WK.-A. Roll 8H, Exposure 11.

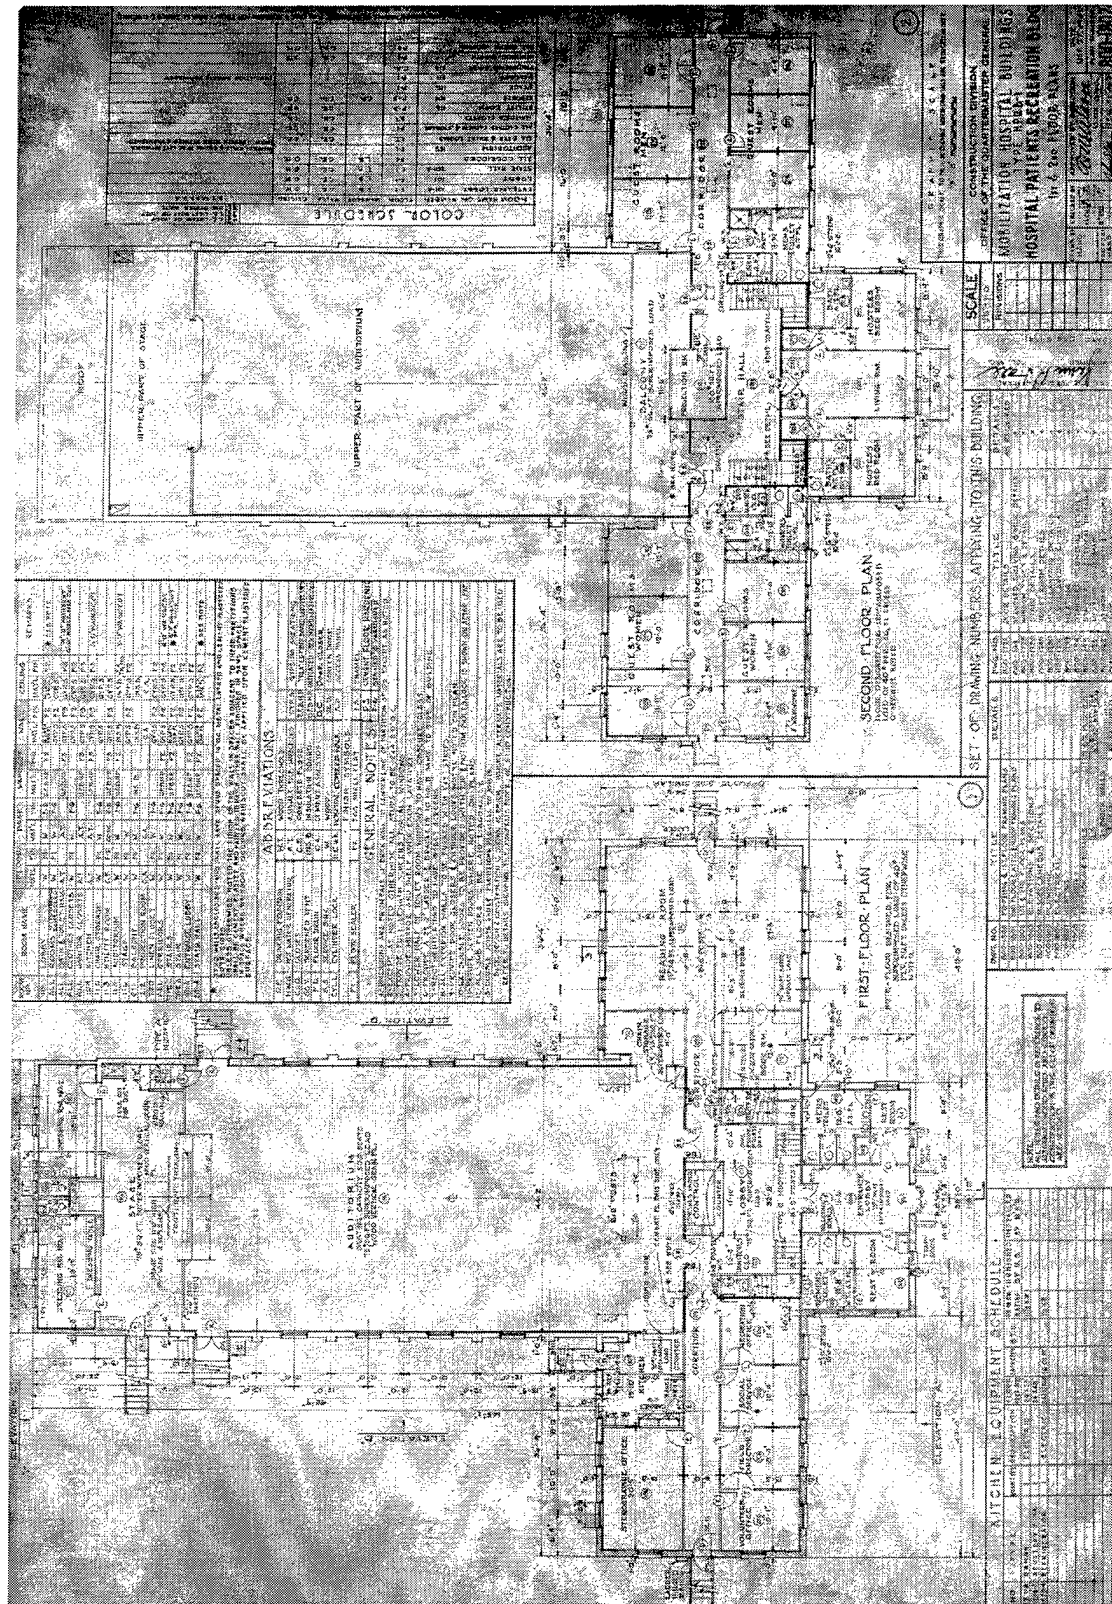
Figure V.203 SEPI778. First- and second-floor plans for Building S6251, Hospital Patients Recreation, 800 Series, Type HPRB-1, Plan 800-1802.

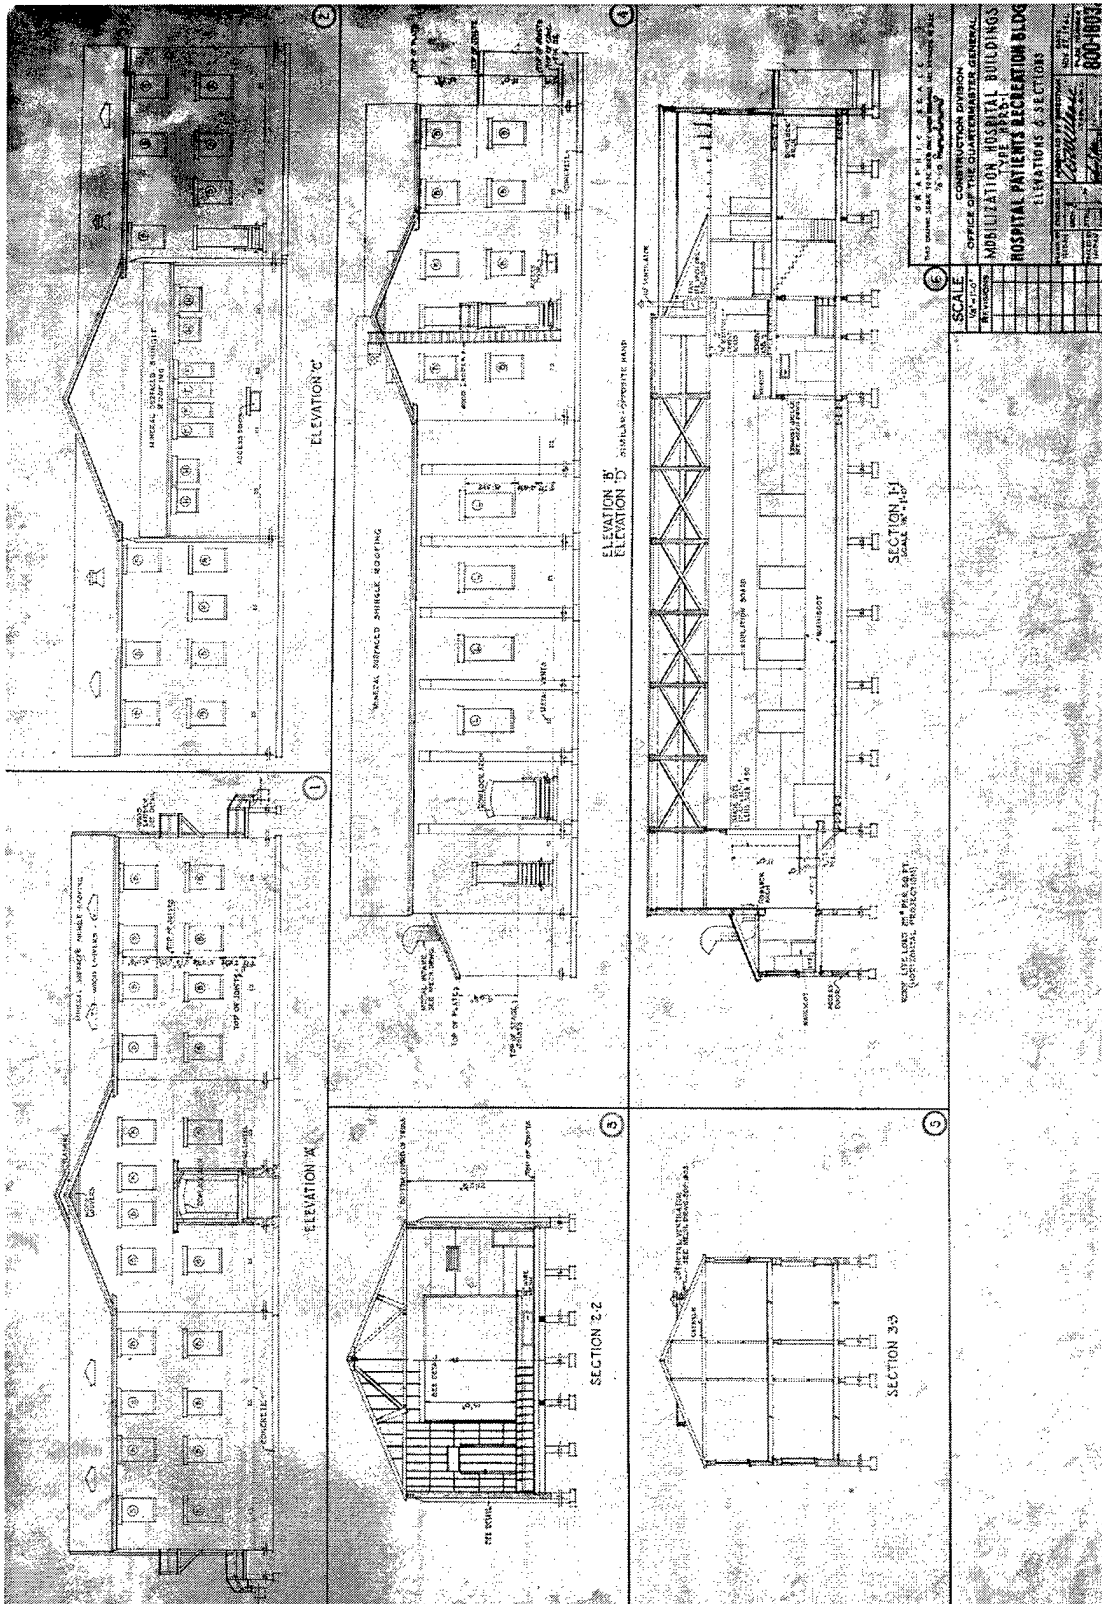
Figure V.204 5EP1778. Elevations and sections for Building S6251, Hospital Patients Recreation, 800 Series, Type HPRB-1, Plan 800-1803.

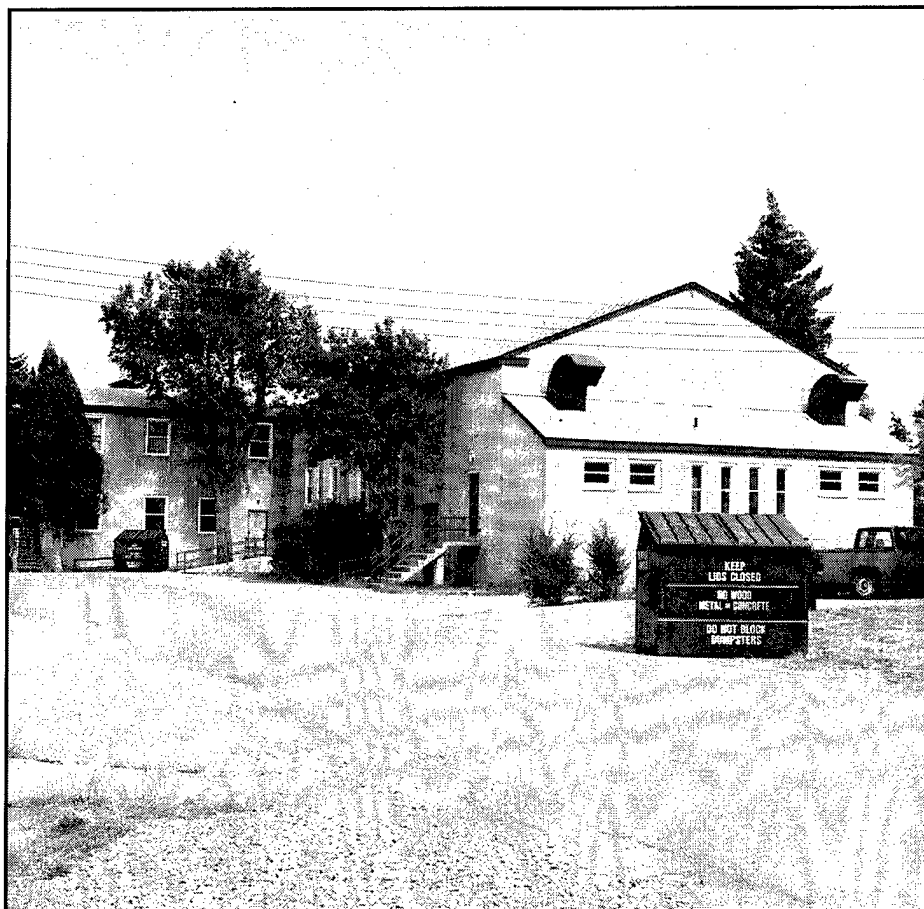
Figure V.205 5EP1778. Building S6251, Hospital Patients Recreation Building, 800 Series, Type HPRB-1. Three-quarter view of north and west facades. Roll 20, Exposure 11.

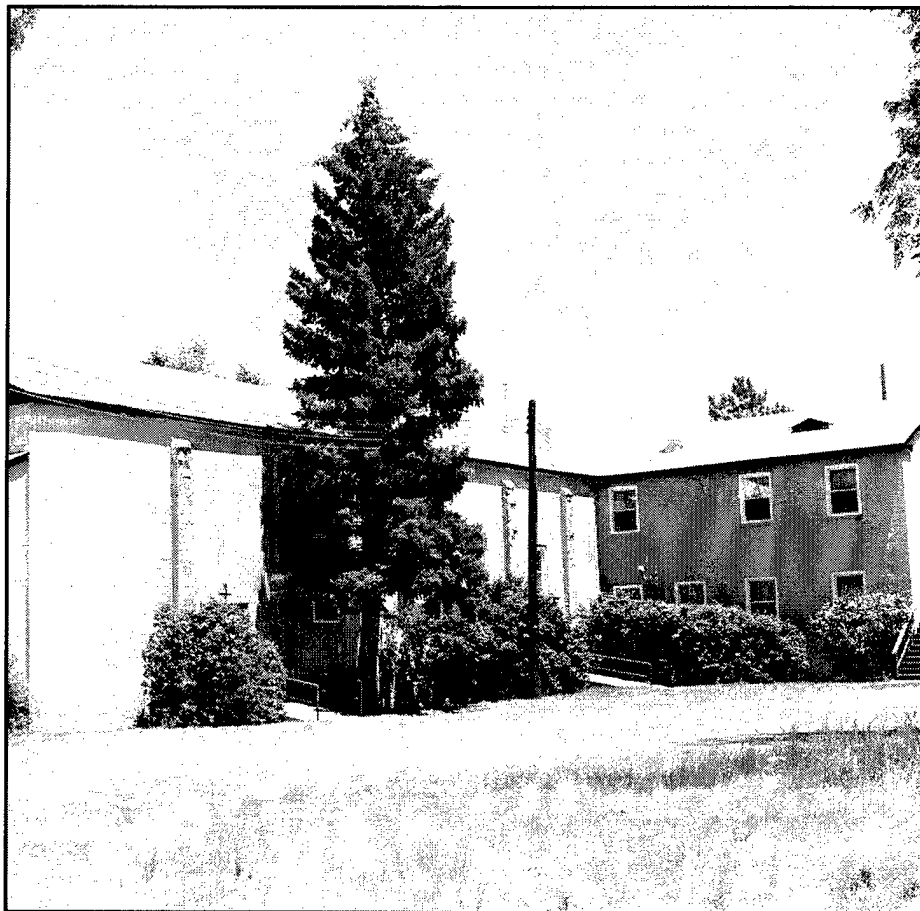
Figure V.208 5EP1778. Building S6251, Hospital Patients Recreation Building, 800 Series, Type HPRB-1. View of south wing's south and west facades. Roll 18, Exposure 6.

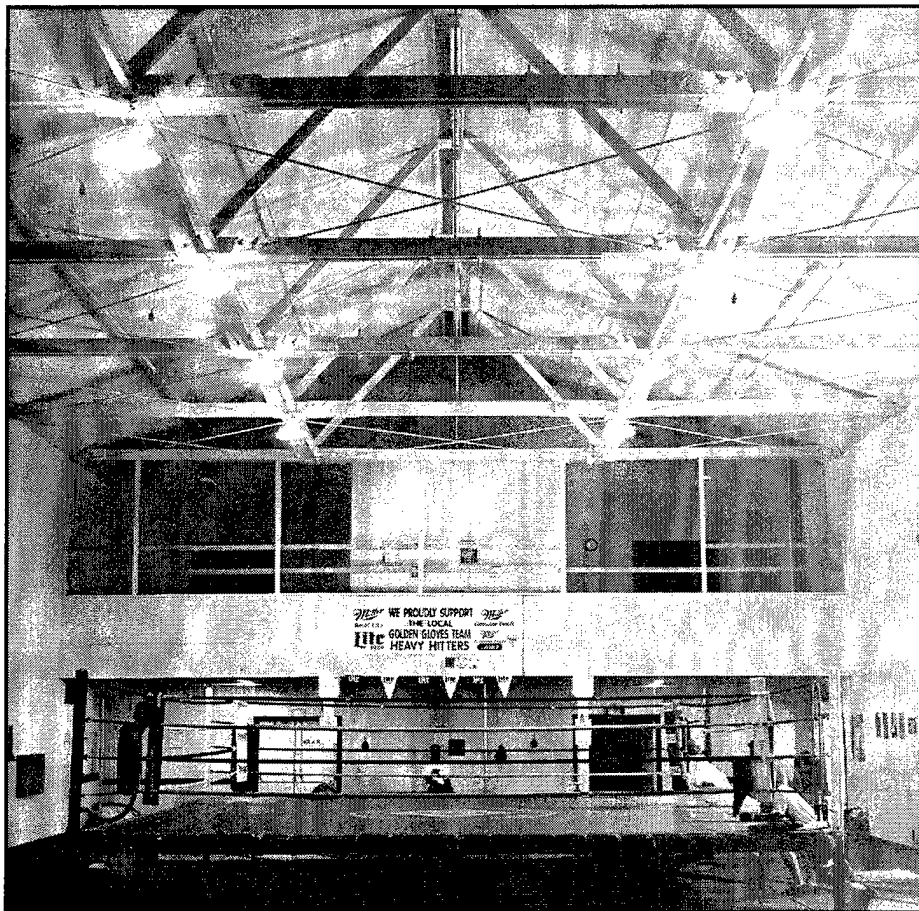
Figure V.210 5EP1778. Building S6251, Hospital Patients Recreation Building, 800 Series, Type HPRB-1. Interior shot of mezzanine and trussing, facing east. Roll 24, Exposure 3.

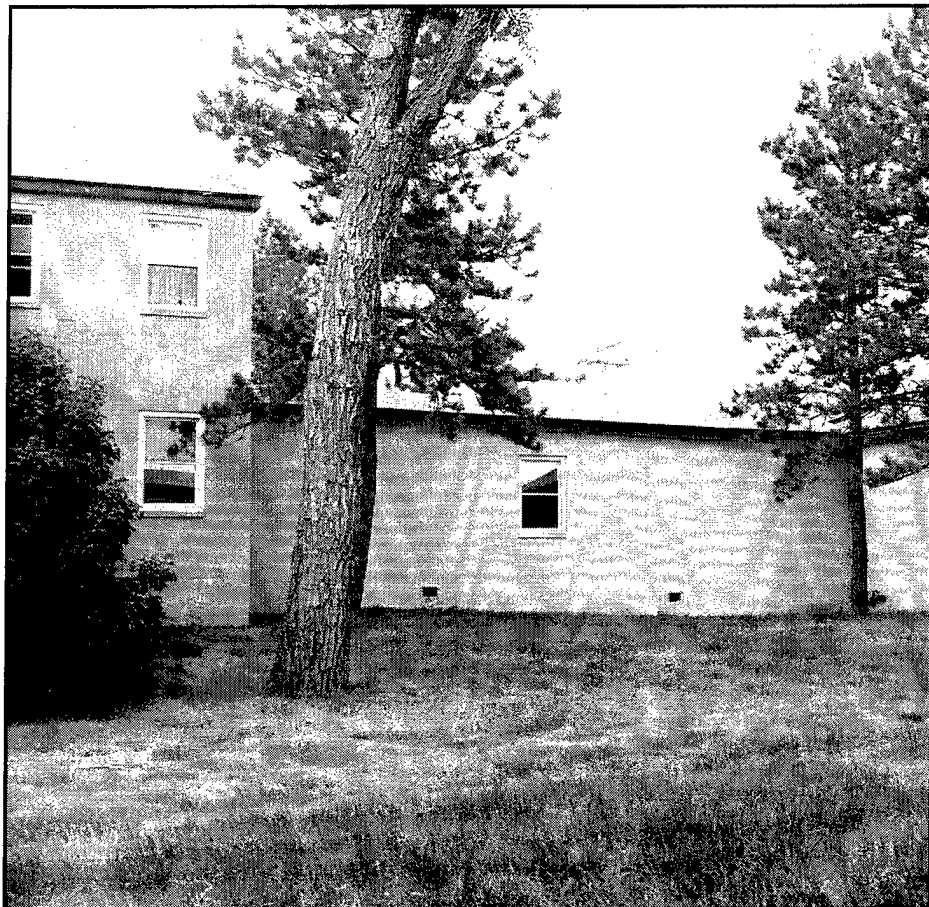
Figure V.211 5EP1778. South face of corridor connecting Building S6251 to a long north-south corridor to the east. 800 Series, Type H.C.WK.-A. Roll 21, Exposure 9.
